**DRAFT  
ENVIRONMENTAL PRIORITIES INITIATIVE  
PRELIMINARY ASSESSMENT  
VOLUME I**

**SKF INDUSTRIES, INC.  
2320 MARCONI AVENUE  
ST. LOUIS, MISSOURI  
EPA ID #MOT300010345**

**JACOBS ENGINEERING GROUP INC.  
10901 W. 84TH TERRACE, SUITE 210  
LENEXA, KANSAS 66214**

**APRIL 13, 1992**

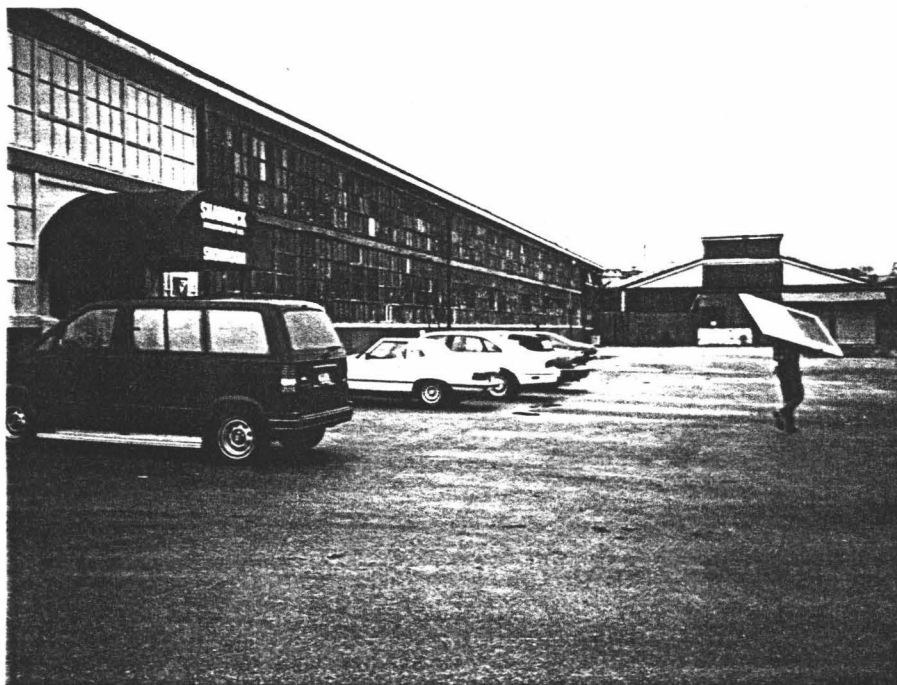
Photo # 6

the east side of the building. A small pile of boards and plastic was observed outside adjacent to the south wall of Building Number 25.

Description: North side of building No. 25. A pile of boards and plastic is to the left of the doors

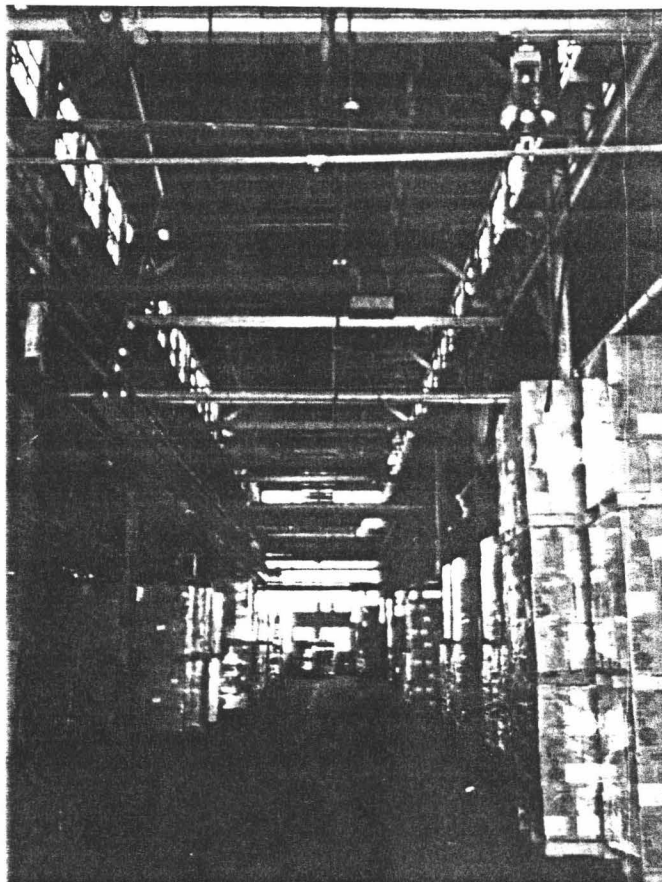
Four large transformers were found stored in a room on the west side of Building Number 4 and oil was observed on the floor beneath them. The transformers were not labeled as to their PCB content. Another room containing electrical equipment was found on the east side of Building Number 4. Four large transformers, three switching boxes, a capacitor, a generator comprised of eight batteries and a 55-gallon drum labeled "PPE" were stored in the room. Oily stains were visible on the floor.

Description: Transformers in east room  
in Building No. 4.  
Switching box is seen to the left of the  
transformers.

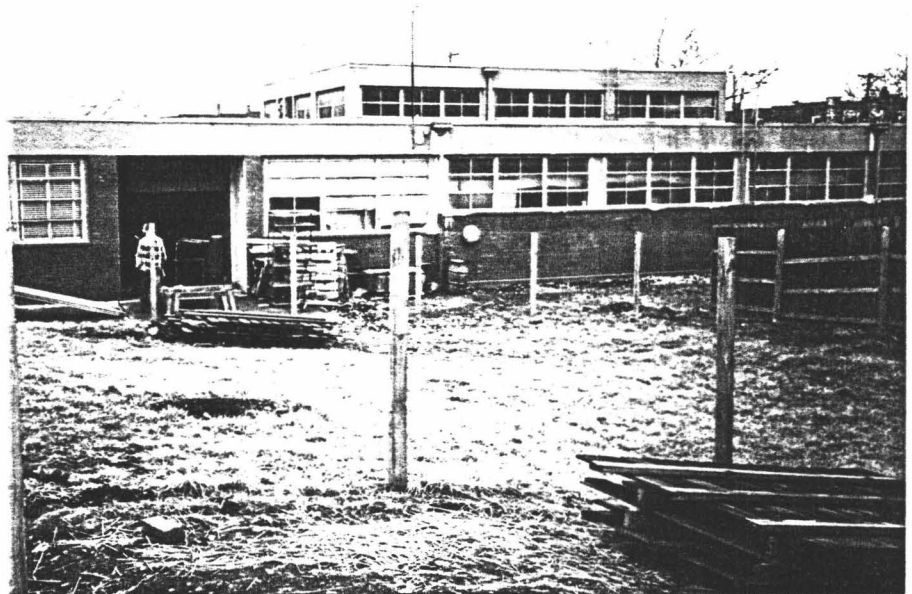
Photo # 26

Description: Building No. 27. Open  
top 55-gallon drum is in center of  
picture.
